Item #1 Recent Failures:

TECHNICAL BULLETIN #6 1980

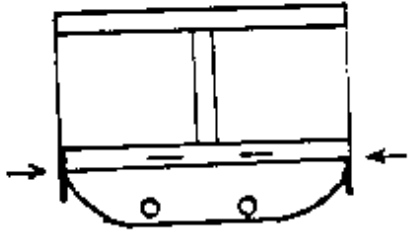
Due to the feedback from the field, i.e. suspension lines entangling with the side flaps on containers, it is recommended that bandstows be added to your Para-File Inc. deployment bag.

Attach two loops approximately 2" long to the binding tape that runs down each side of the deployment bag. The loop that is sewn on the open side of the bag should be placed on the binding tape that holds the 2" pile velcro to the bag.

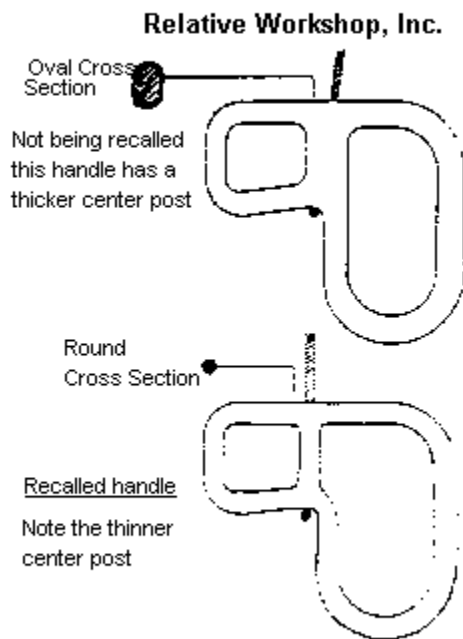
Item #1 Ripcord Recall:

Wonderhog owners that have the type of ripcord being recalled (see diagrams below) should send the entire ripcord to the Relative Workshop together with the following information: the name and mailing address of the owner; the serial number and date of manufacture of the rig (this information is on the TSO tag that is tucked behind the back pad at the top of the container); the name of the person or dealer from whom the rig was purchased, and whether the rig was purchased new or used. For Wonderhog owners who are not able to supply the above information, or obtained plastic handles from another source, such as blast handle conversions, the Relative Workshop will provide replacement ripcords with a metal handle for \$5 if they return the old ripcord.

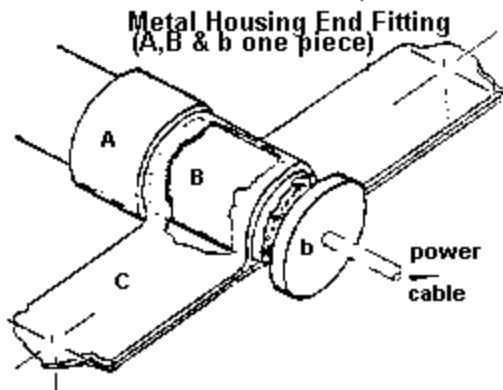
Item #7 Mounting of AAD Power Cables:

Reports received have identified a potential problem with mounting of the power cable for mechanical action AAD units. Movement of the housing towards the pins during firing of the unit is possible if the end of the power cable housing is not properly secured with a mounting plate (stiffener) and housing clamp. Both the FXC 12000 and SSE Pin Puller (for SSE 2000) use a metal housing end fitting which is shaped to mate precisely with a metal "U-shaped" mounting clamp. Slippage may occur if the mounting clamp is not fully tightened into position, if a soft material (e.g. rubber bushing) is inserted within (between B and C) the clamp or if a clamp other than that provided by the manufacturer is used. Slippage of the housing if the mounting screws are not tightened is obvious. Insertion of a soft material will appear to make a snug fit but under the shock of AAD firing may prevent the mounting clamp (C) from catching against the ridge (A) on the housing end fitting - slippage of the housing may result. Using a clamp other than that provided by the manufacturer may result in incorrect alignment of the housing end fitting, with a similar result. Any amount of movement of the housing end fitting towards the pins could result in incomplete extraction of the ripcord pins. Immediate inspection of all AAD installations is strongly recommended. Correction of any deficiencies should be performed before further use of the equipment.

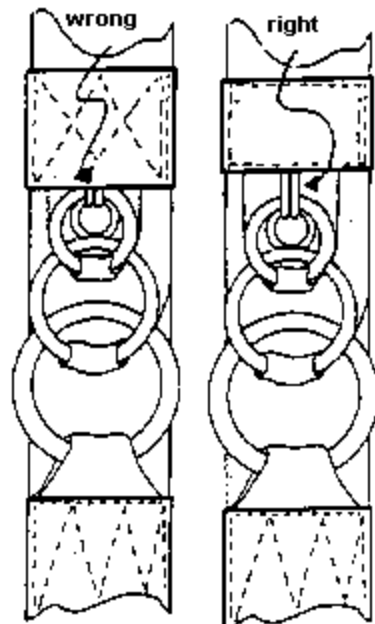
improperly made 3-ring riser (left)

Many construction features of 3-Ring risers are critical to the proper operation of a 3-Ring system. Riggers encountered a pair of risers that had a three-point WW stitch pattern instead of the recommended box pattern around the confluence wrap. (See sketch.) The incorrect pattern allowed the confluence wrap to capture the small ring; one riser wouldn't release when the rigger tried to disconnect the main canopy to repack the reserve. (Note how the edge of the small ring slid under the edge of the confluence wrap effectively preventing the 3-ring mechanism from releasing.)

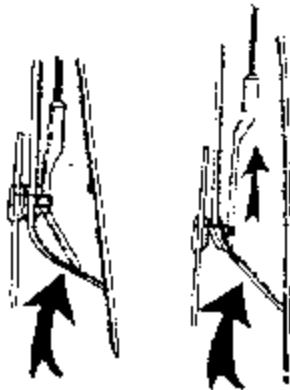
The reserve pin will bend if something catches under the top flap of the reserve. Even if the pin doesn't bend the force against the tip of the pin could cause it to slide out of the locking loop. The company believes this can occur when a jumper leans against something in the aircraft or during canopy relative work when a canopy's nose catches under the flap.

Side views of the Vector reserve ripcord, showing how bending the top flap can bend the pin (left) and push it out of the locking loop (right)

Bill Booth, designer of the rig, recently displayed one possible solution: revising the closing order of the top and bottom flaps and installing a small channel in the bottom flap to receive the end of the pin. The modification would require changing the top flap.

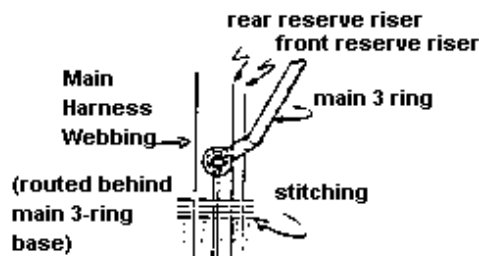
FAULTY CONSTRUCTION

The problem involves the routing of webbing through the large 3-ring on the harness and the positioning of the main risers (see diagram). The system was test dropped by an independent testing authority under APF (Australian Parachute Federation) supervision. The test drops were carried out to the design standards approved by the Department of Aviation. The drops simulated the forces that would occur during a parachute opening sequence.

The second drop resulted in complete failure of all harness stitching on one side of the main lift web.

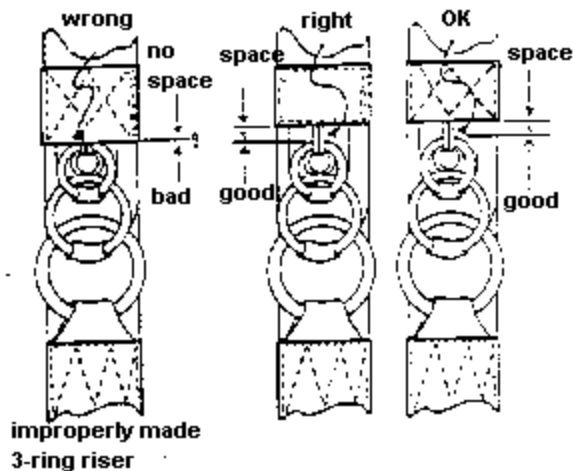
The item refers to the incorrect manufacture of a 3-ring riser. A diagram with Technical Bulletin 21, Item #7 shows the small ring being overlapped by the confluence wrap. The text accompanying the diagram states, "The incorrect pattern (3 point cross stitch) allowed the confluence wrap to capture the small ring", preventing it from functioning during an inspection. It should be clarified that this type of stitch, a 3 point cross stitch, was not the primary cause. Rather, the confluence wrap was placed and stitched into such a position as to allow the small ring to tuck under it. Therefore, a poorly placed and poorly box or cross stitched confluence wrap could effect the same result.

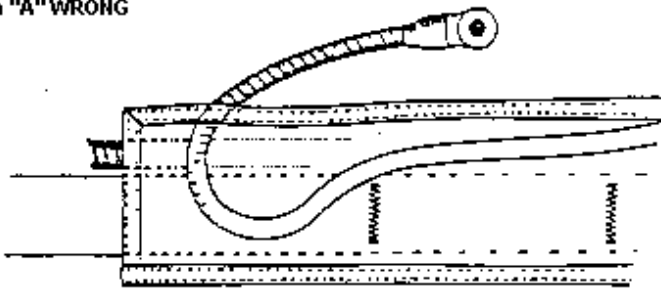
Diagram "A" WRONG

Note: The proper distance for the housing to stick out of the pad is 4.5" to the centre of the eye for standard rings and 3.75" for mini rings.

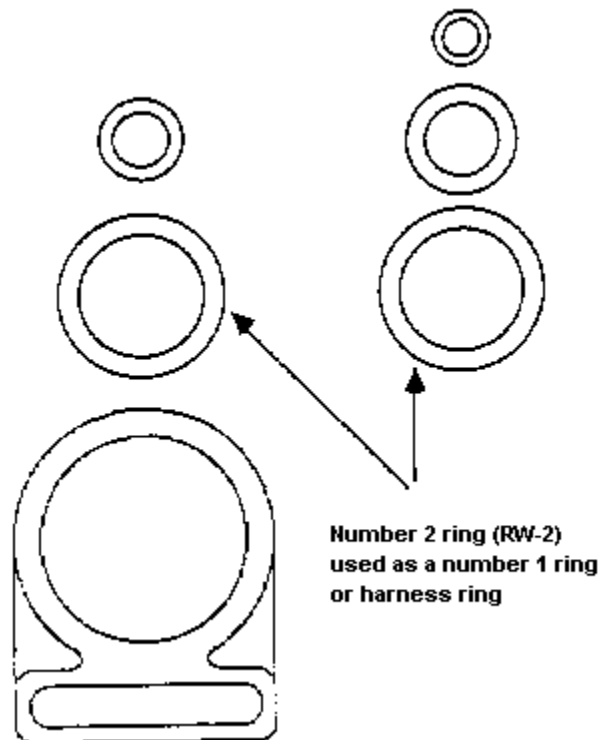
The RW-2 ring is softer than the RW-1 rings grounded in the 1984 FAA Airworthiness Directive. RW-2 ring factory proof load testing is only 500 lbs., however, opening shock loadings of 2,000 have been measured. Permanent deformation of the RW-2 ring can occur with a loading as little as 850 lbs. Deformed or elongated rings can cause a 3 Ring system to completely lock during operation on a cutaway.

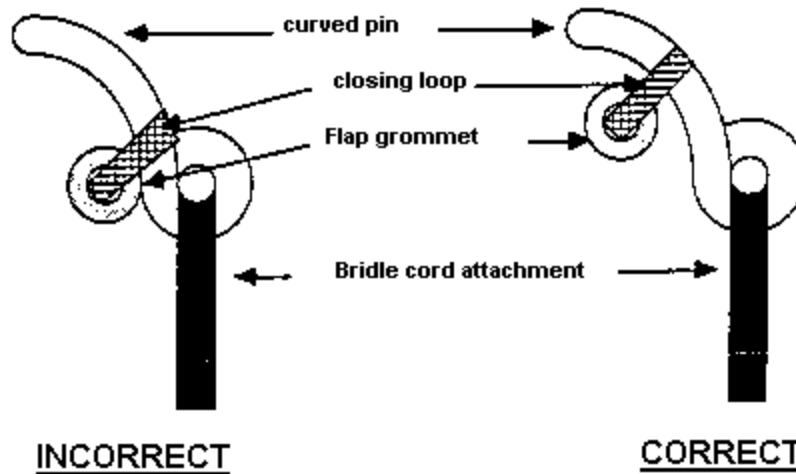
A series of pilot chute in tow malfunctions reported to Para-Phernalia, Northern Lite III manufacturers, has been attributed to the curved pin being buried in the main closing loop.

The manufacturer indicates that it is mandatory that the curved pin not be buried and that the pin position be adjusted so that the closing loop is midway on the curved pin (see diagram below).

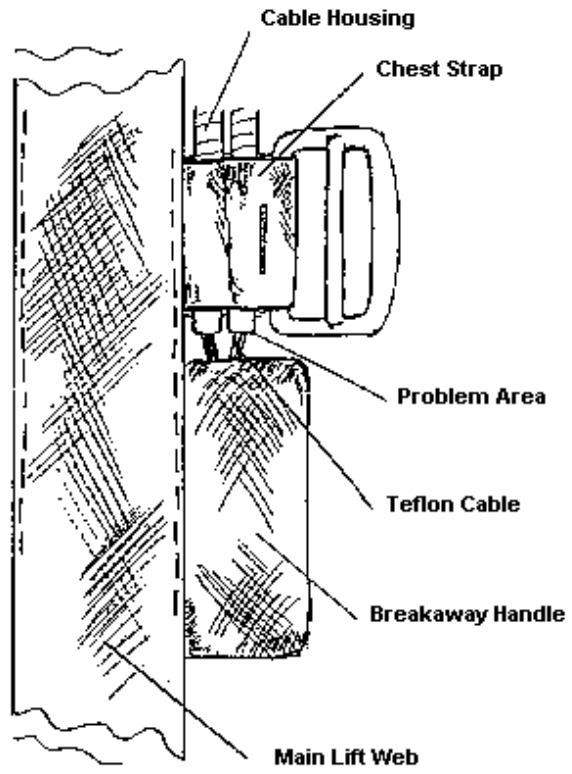
There have been several reports from the field of damage occurring to the Teflon covering used on break-away cables. This damage is being caused by poor finishing on the inside of the cable housing where the end ferrules are attached. This damage to the cable covering could result in excessive pull forces on the break-away handle. Housing should be checked, inside and out, to ensure that the ends are smooth.

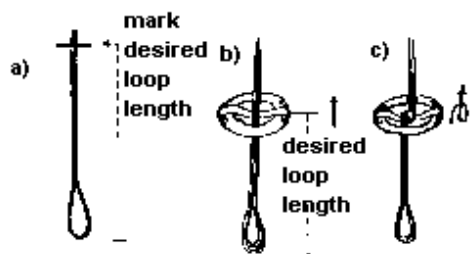
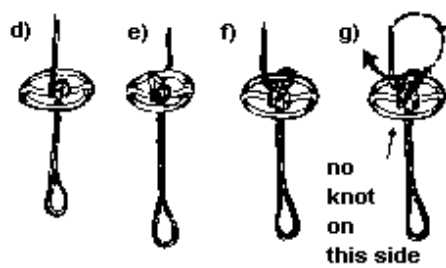
An alternate method of retaining the special Cypres reserve closing loops was introduced during 1993. The older, but still acceptable, method illustrated below left involved a greater degree of manual dexterity vis a vis the tying of knots than the method now being suggested, shown below on the right.

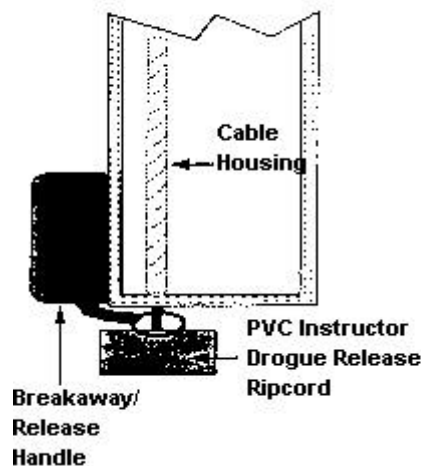
Although Strong Enterprises does not require that the installation be made by a certified rigger, owners of the tandem system should be aware of a potential problem. When assembled correctly, the ring must be below the handle pocket and above the instructor's drogue-release handle (as shown in the diagram). It is possible to place the ring inside the breakaway handle pocket and still have it between the cable housing and the drogue-release handle. However, this configuration can produce a hard pull or make it physically impossible to remove the drogue-release cable from its housing.
