Item #1 Recent Failures:

TECHNICAL BULLETIN #6 1980

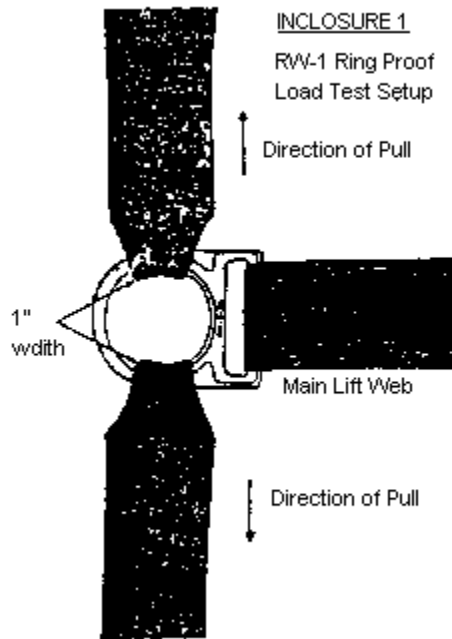
3-Ring Release Safety Bulletin A detailed investigation into the reported failure of the large 3-ring has resulted in the following:

2. All rings stamped RW-1-82 or RW-1-83 may be defective; therefore, any harness equipped with these rings cannot be jumped unless one of the two following options are met:

Option #1 - replace all suspect rings. A separable ring is currently available, (stamped RW-6-84), which will enable a quick and easy replacement of all suspect rings. Upon request, replacement rings and complete installation instructions will be provided from your harness container manufacturer. (Note: a heavy duty bolt cutter will be required to remove the suspect rings.)

Option #2 - test all suspect rings. An FAA Master Rigger is authorized to certify that suspect rings are not defective as follows:

2) Subject each load to a 2,500 pound (1134 kg) proof load. Measure the internal diameter of the large ring prior to testing with a micrometer at eight points around the circumference; load the ring to 2,500 pounds, relax the load, and remeasure the ring at the same eight points. Rings which show no deformation more than 0.020 inches are acceptable. Any ring showing deformation more than 0.020 MUST BE REPLACED. (Note #1: defective rings will noticeably distort when loading reaches approximately

3) Harnesses using rings which have been tested and are found to be acceptable, must be designated by permanently affixing a rigger's seal (with symbol) using wire (not red rigger's thread) to the right ring's webbing slot. The seal must be attached to the square portion of the ring through which the main lift web passes, not the round portion.

6) In the event that a harness has only one acceptable ring, BOTH RINGS MUST BE REPLACED.

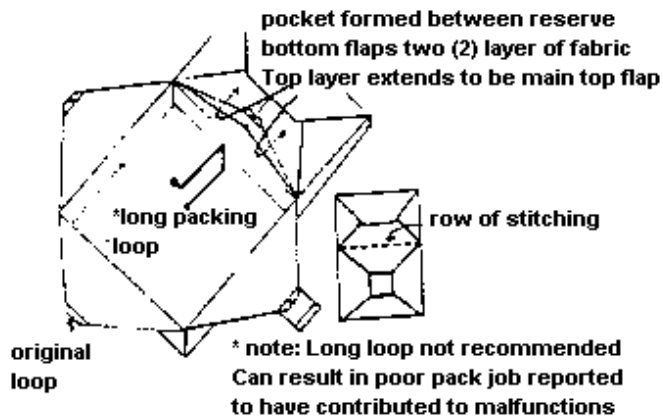
An incident occurred where a copy of a Wonderhog was about to have the reserve repacked and when the reserve ripcord handle was activated the pilot chute did not deploy because the main was still in the deployment bag inside the container and had been pulled up so that the bag (even though inside the container) had pushed up over the reserve pilot chute preventing it from deploying. On some copies, and on some Wonderhogs, the top of the main container flap and the bottom of the reserve container flap are not stitched separating them (see drawing) thus allowing the main deployment bag to ride up. It is suggested that stitching is added (consult a Rigger) or a long packing loop is attached to the base of the main container, which when closed will pull the main deployment bag away from the reserve.

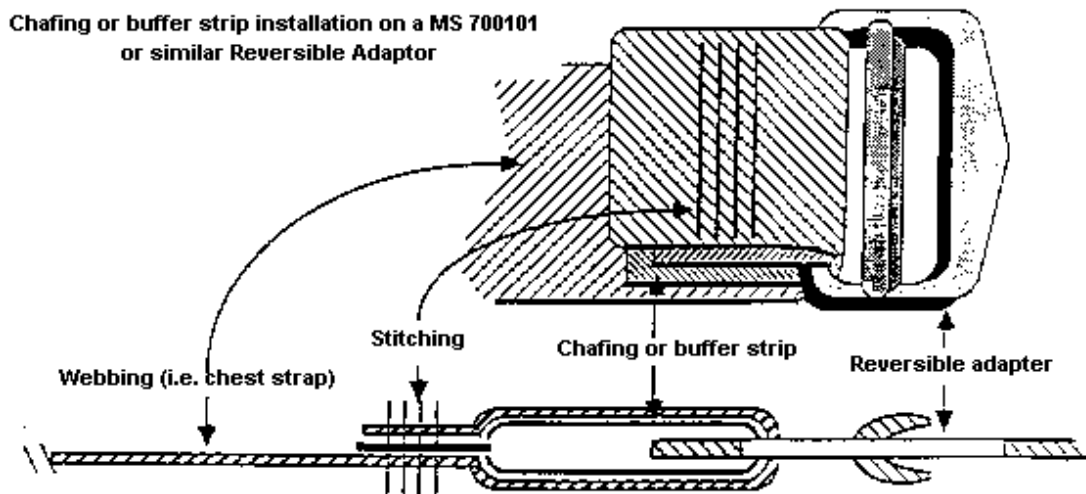
Note: Adaptors of this type are very common to sport parachute harness and container systems. They are most often found on chest straps, belly bands and horizontal back bands.

Modification to include a chafing, (buffer) strip requires sewing machine stitching and, therefore, should be done by a FAA Senior rigger or CSPA rigger B.

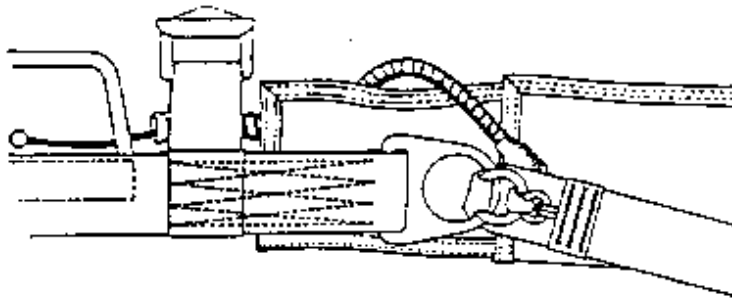
Left Side

Note: The proper distance for the housing to stick out of the pad is 4.5" to the centre of the eye for standard rings and 3.75" for mini rings.

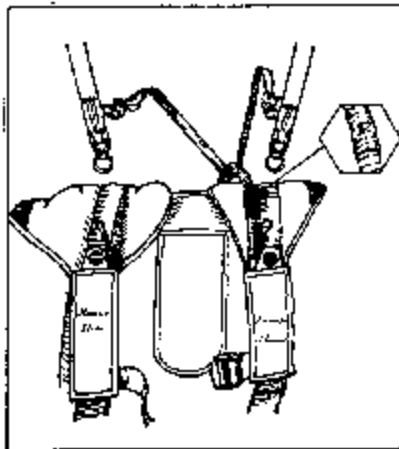
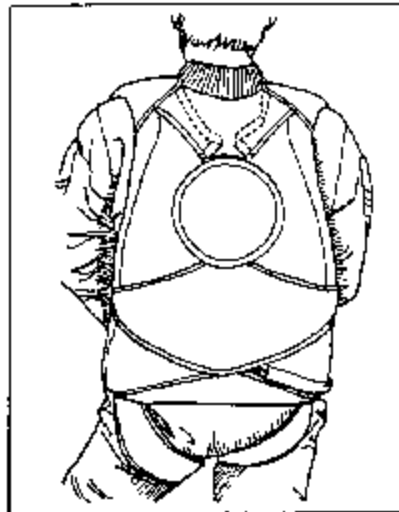
Owners of the Racer Elite harness/container systems should also be made aware that in the event they have a reserve canopy deployed before the main, and wish to release the main canopy, the RSL must be disconnected before initiating the breakaway procedures. Failure to do so could result in the main canopy, still attached to the RSL, sliding up the reserve lines and collapsing the reserve canopy.

Note: To preclude the possibility of inadvertently routing the static line under the top flap we recommend that the reserve be packed and sealed before taking the following steps.

- A. Pass one end under the top half of the reserve ripcord housing, BUT NOT UNDER THE RESERVE RISERS OR THE TOP FLAP OF THE RESERVE CONTAINER.
- B. Connect the shackle to the small ring located on the side of the riser.
- C. Repeat for the other side.
- D. Store the reserve static line in the channel over the wearer's shoulder and mate the velcro on the yoke or top flap.

The RSL on this system can be optionally assembled to a single riser. Ensure that the lanyard is properly routed under the reserve ripcord housing and both snap shackles are attached to one riser ring. (As per manufacturer's specifications)

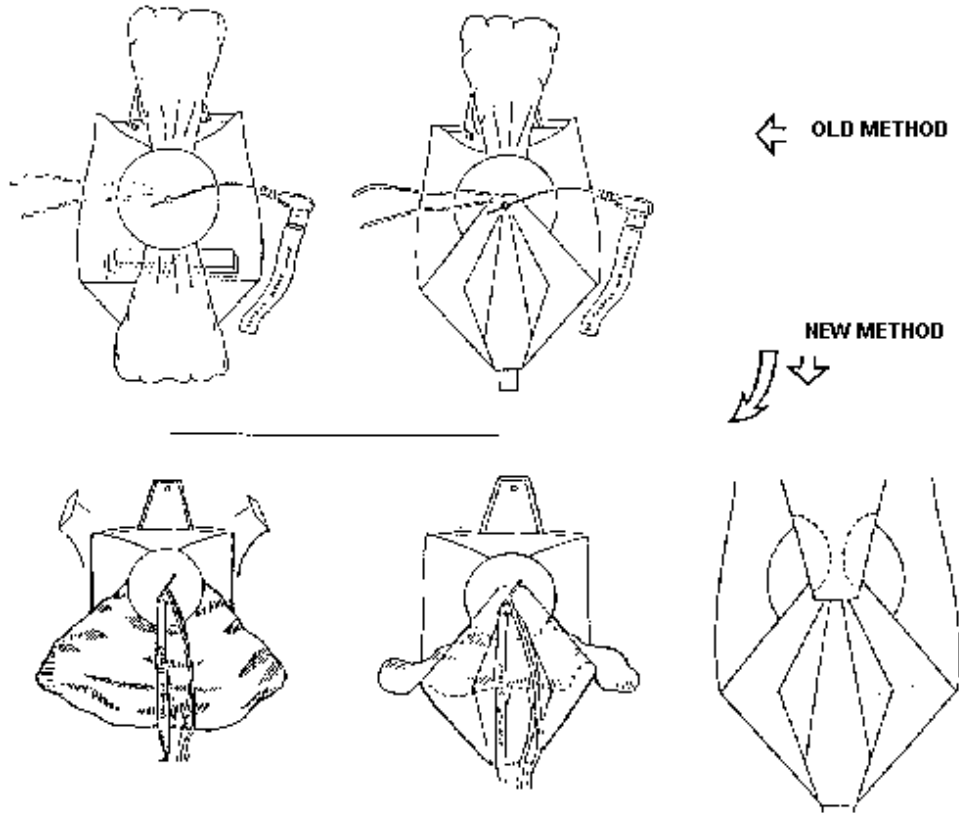
The revised instructions tell the rigger to follow the same basic steps except the pilot chute fabric is rolled and positioned differently; most of the fabric ends up under the bottom flap.

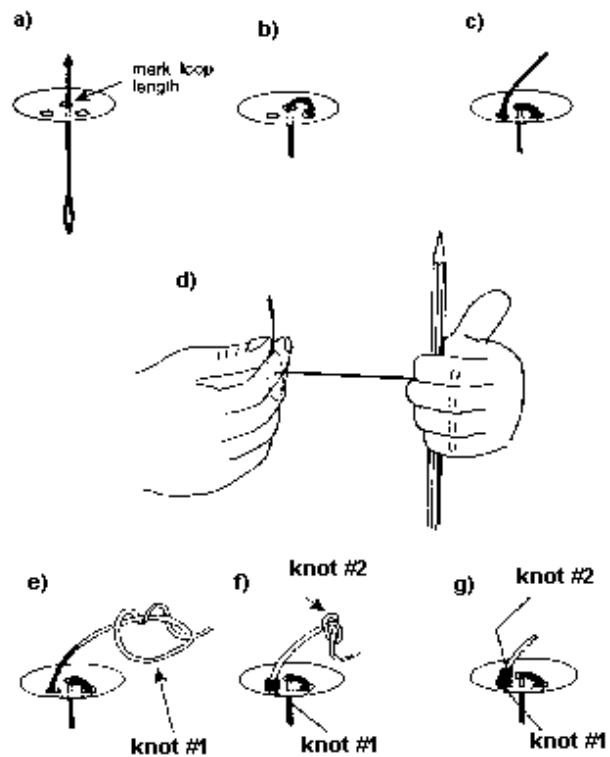
An alternate method of retaining the special Cypres reserve closing loops was introduced during 1993. The older, but still acceptable, method illustrated below left involved a greater degree of manual dexterity vis a vis the tying of knots than the method now being suggested, shown below on the right.

Remember, when packing equipment that has a Cypres installed, you must use pull-up cords of the same material as that of the closing loops. The specific cords are also available from Airtec.

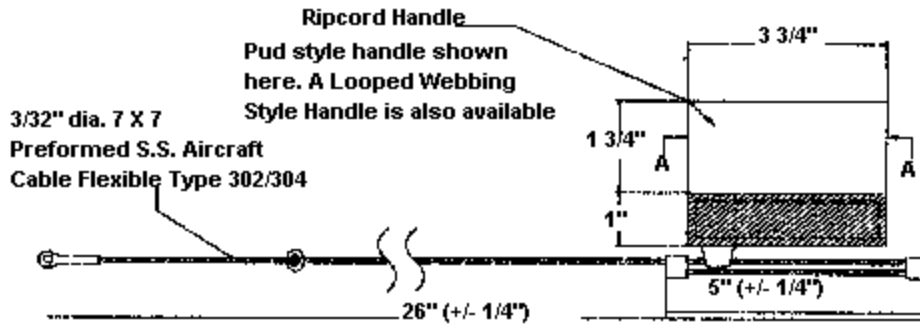
Riggers are reminded that it is their responsibility to ensure that all components are compatible. The situation described above should have been caught by the rigger at repack time. Determining the correct ripcord length and compatibility on a Tandem system is no different than the method used on other systems. Remember, SCF!

The Relative Workshop recommends using the newer loop-style handle as opposed to the older pillow type. The new handle is easier to see and pull in most situations.

The tolerance given (+/- 1/4") for the ripcord length are the same tolerances used by Capewell when manufacturing reserve ripcords.
